UNDERGROUND WATER TANK RESTORATION & EPOXY COATING

Durable, NSF-Certified Tank Lining Restores Integrity in Coastal Environment

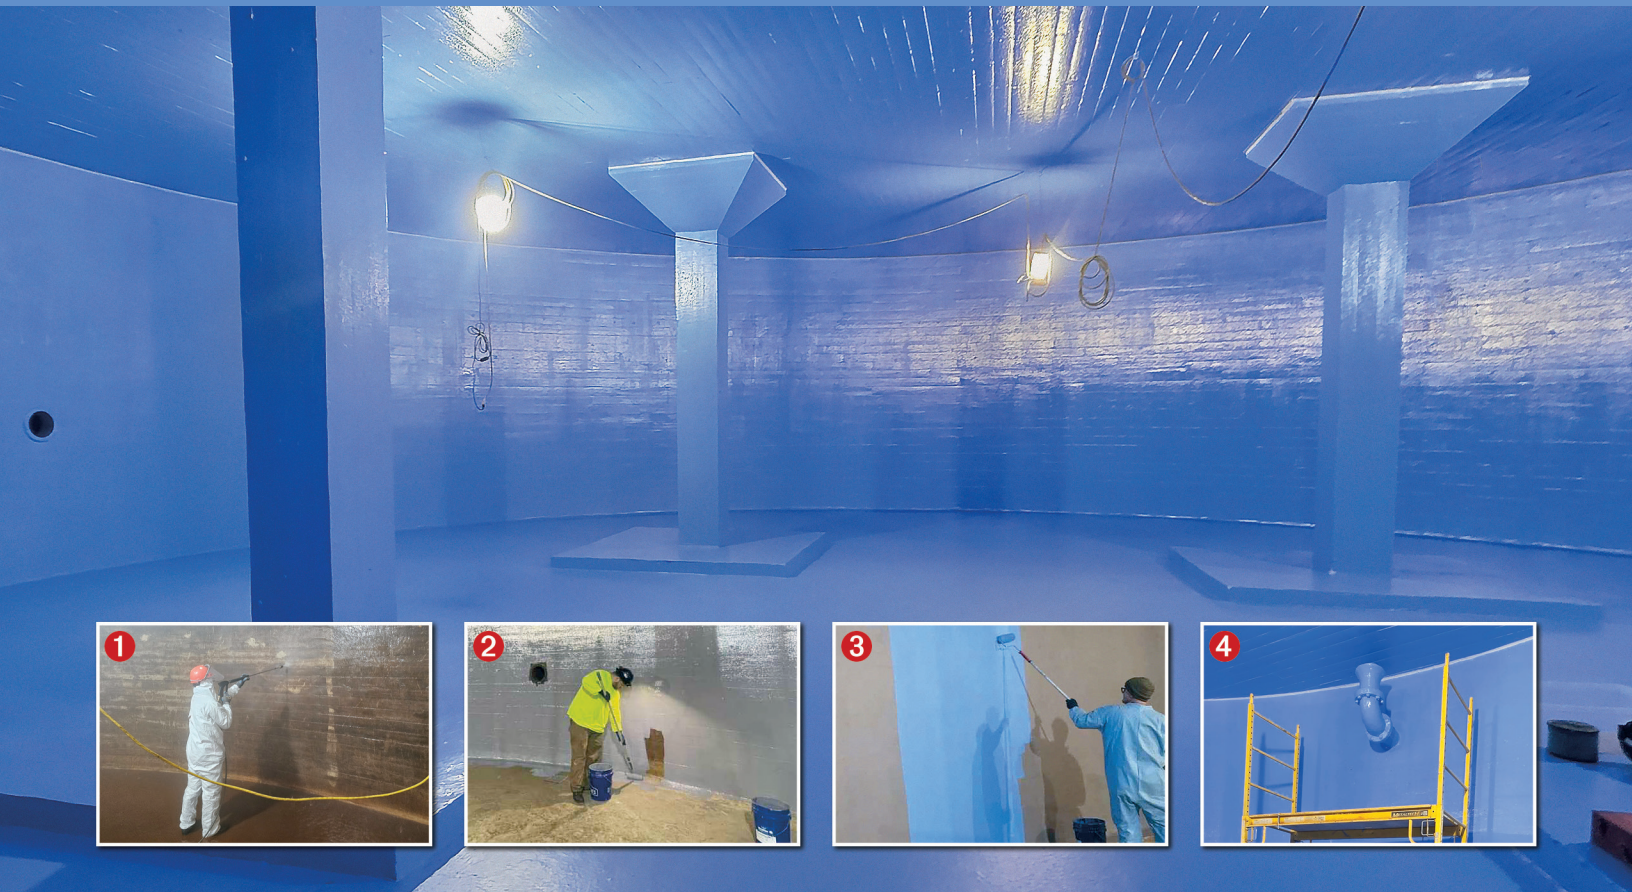
A construction company specializing in environmental remediation partnered with Banks Industrial Group (BIG) to restore a deteriorated underground potable water tank at Fort Hancock in Sandy Hook, NJ. The concrete tank had suffered spalling, cracking, and severe pipe corrosion due to age and its coastal location. BIG pressure washed, repaired the concrete, reinforced piping with Belzona 1111, and applied NSF-approved Belzona 5812DW epoxy to 10,000 sq. ft. of internal surface. The cold-applied, corrosion-resistant coating ensured safe, long-term water storage without the need for tank replacement. Completed in under a month, the project delivered lasting protection, minimized downtime, and met potable water standards.

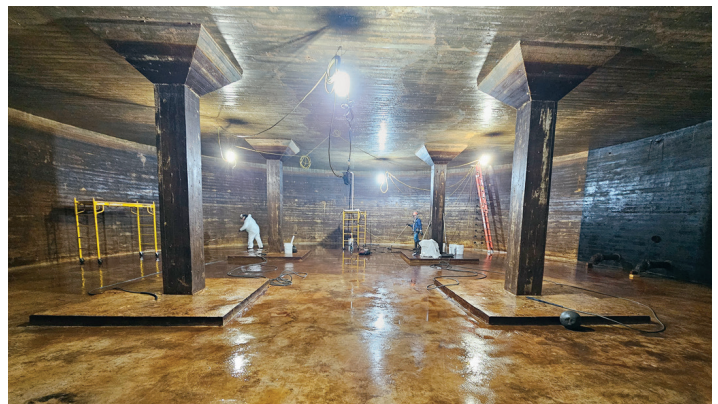
Surface prep of 10,000 sq. ft. underground water storage tank.

- 1 Surface prep of concrete to correct profile
- 2 First coat of gray Belzona 5812DW
- 3 Final coat of blue 5812DW for proper thickness
- 4 Concrete joint seam sealing & refurbished pipe
