OVERHEAD CONCRETE REPAIR

Specialized Belzona repair method saves facility \$800,000+

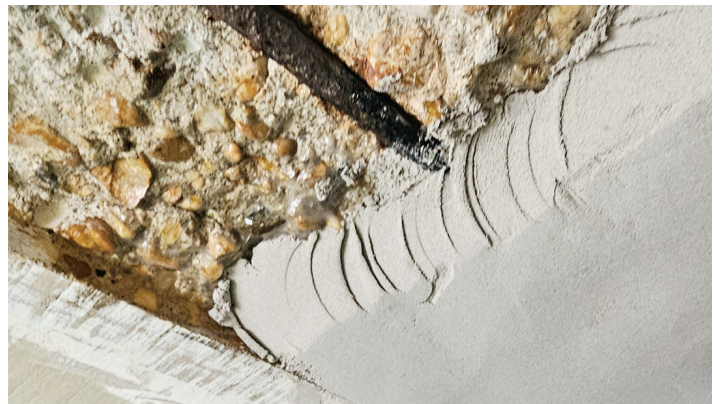
Belzona 4141 is applied overhead without formwork.
