# HEATING CYLINDER CORROSION REPAIR

## Restoration of Corroded Cylinders Minimizes Risk of Power Plant Outage

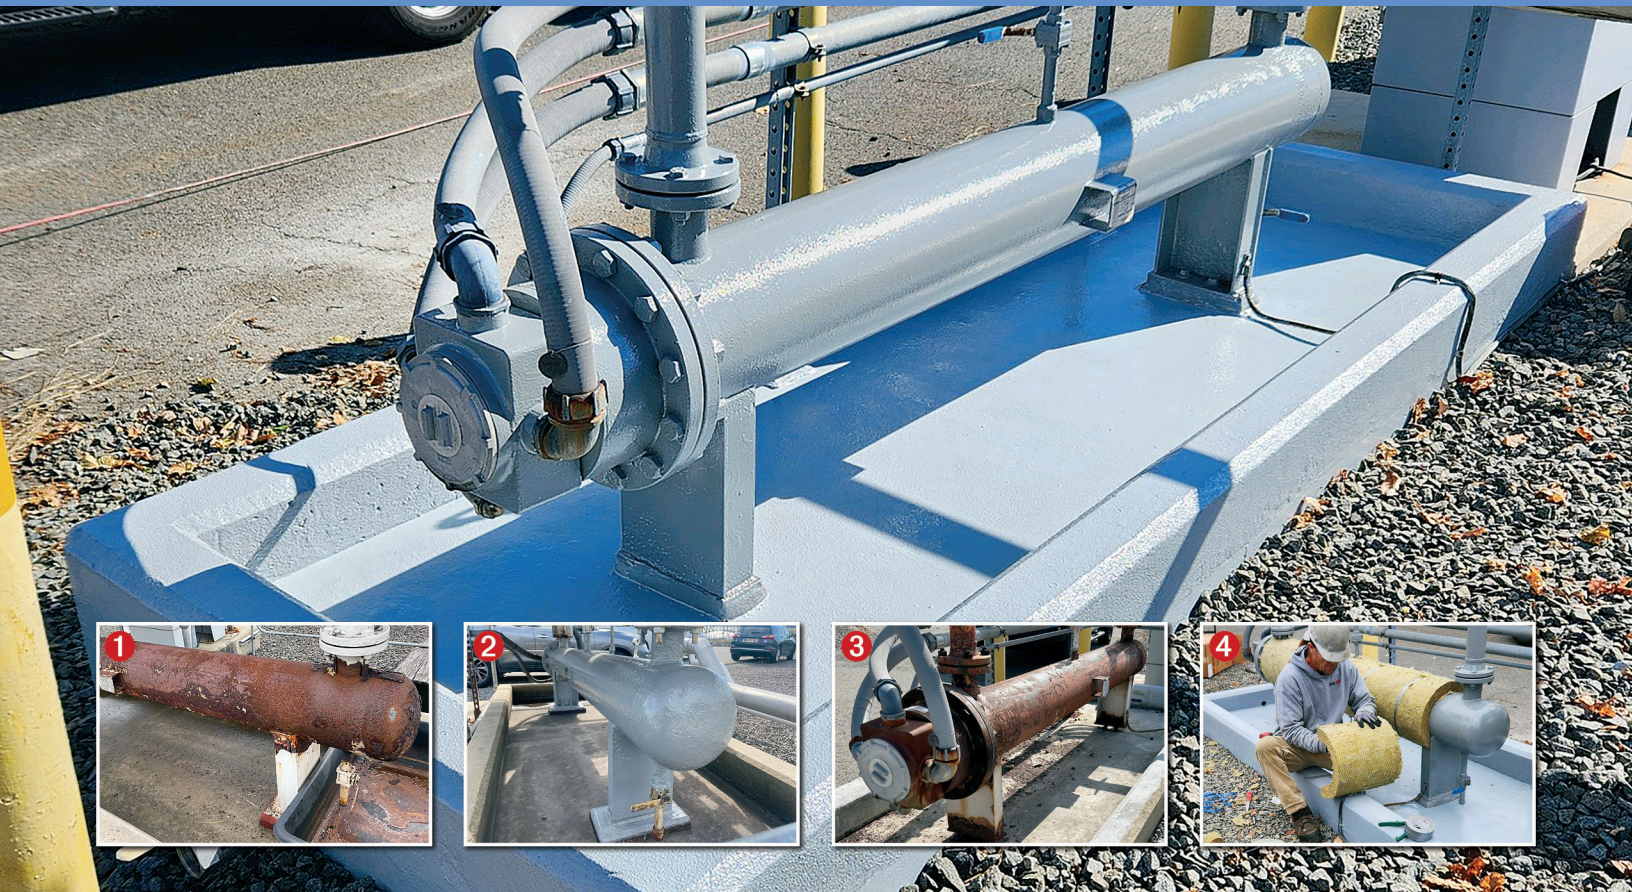
This Northern New Jersey power peaking plant faced a critical challenge with corroded fuel oil heater cylinders, risking oil leaks and unplanned outages. Banks Industrial Group provided a cost-effective solution by repairing the corrosion under insulation using Belzona 5831ST coating and addressing corroded shut-off nozzles with Belzona SuperWrap 2. The three-day repair, costing under \$20k, ensured long-term protection, extended equipment service life, and safeguarded the plant from potential daily losses in the millions. The plant is now prepared for winter power peaking, with averted environmental risks and minimized financial impact.

- ❶ Severe corrosion of cylinder and shut-off nozzle
- ❷ Repair and protective coating
- ❸ Corrosion under insulation revealed
- ❹ Re-insulated after Belzona repair coating

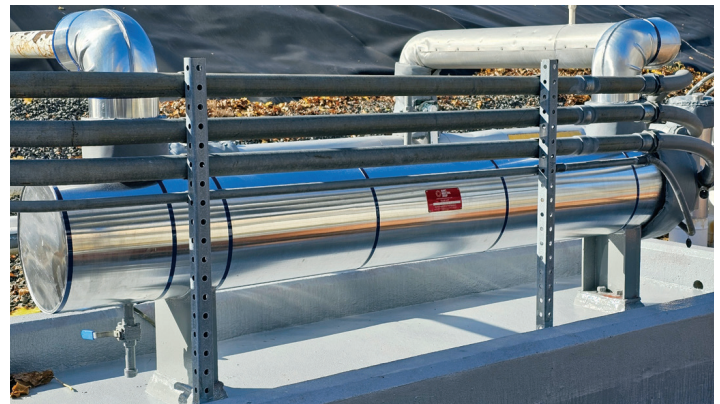
*Cylinders were re-insulated after repair and coating application.*
