# TUBE SHEET CORROSION REPAIR

## Restoration of Corroded Tube Sheet Minimizes Risk of Air Condition Outage

## Step-By-Step Corroded Tube Sheet Restoration

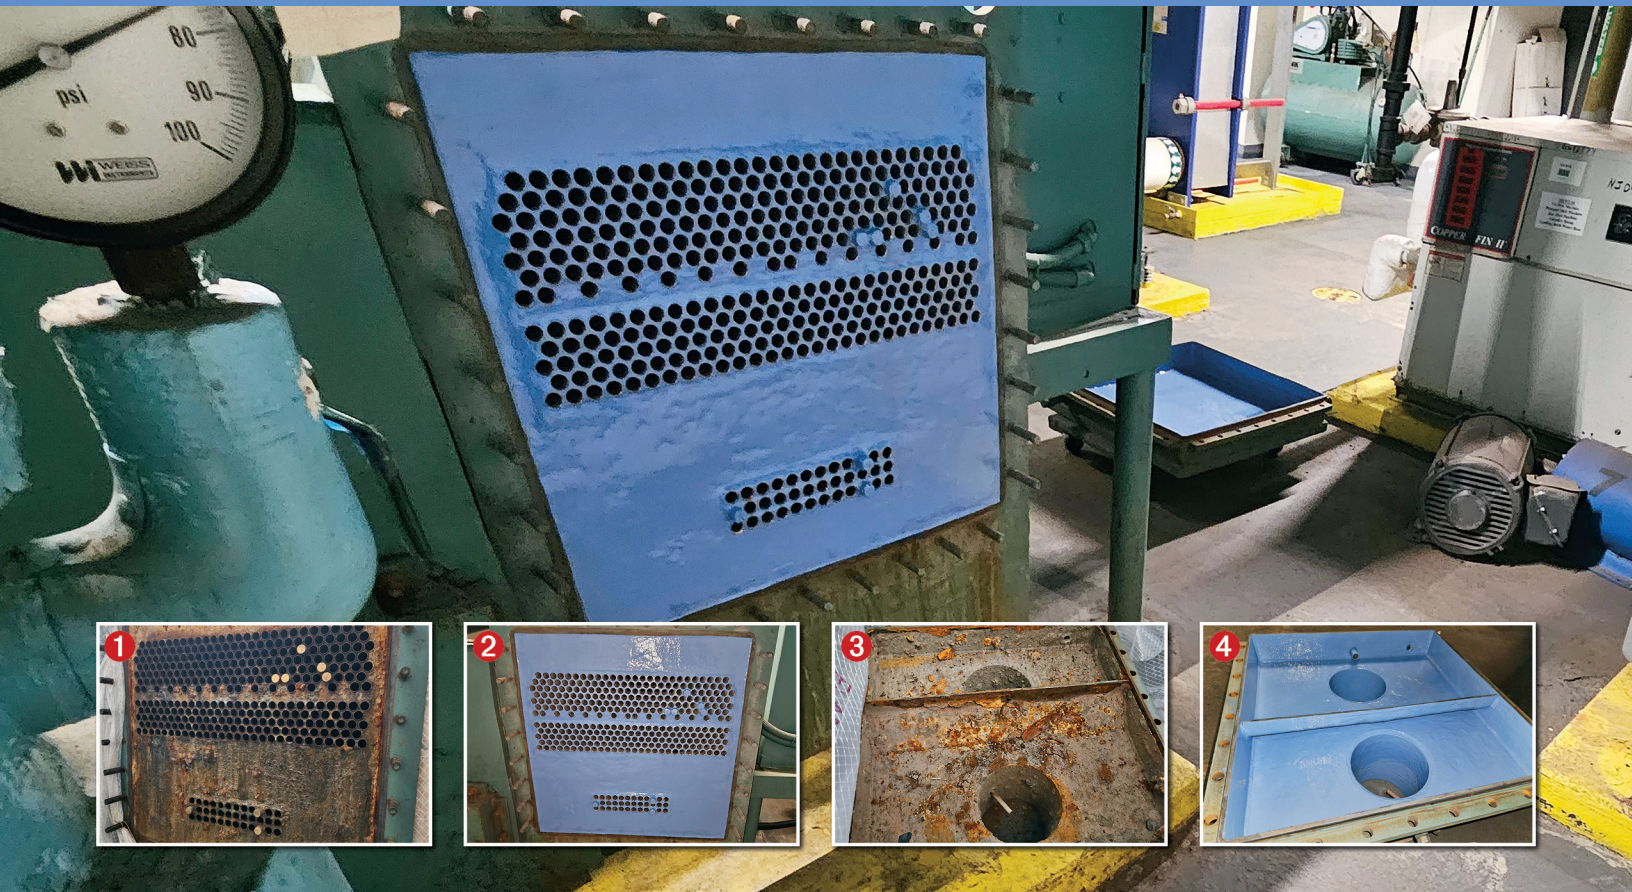
- 1 Corroded tube sheet prior to surface prep**
- 2 Restored and protected against future corrosion**
- 3 Corroded chiller end cap prior to surface prep**
- 4 Corrosion repaired and protective coating applied**

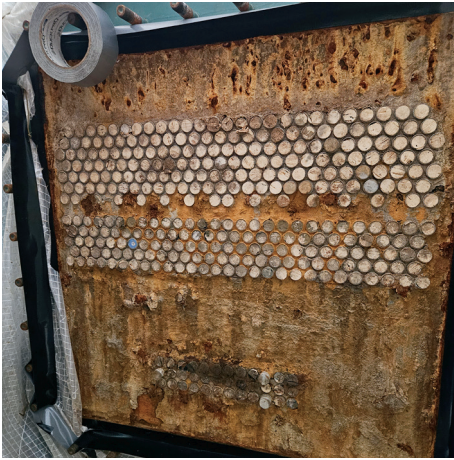
End cap removed and exchanger tubes are sealed with corks prior to surface prep.

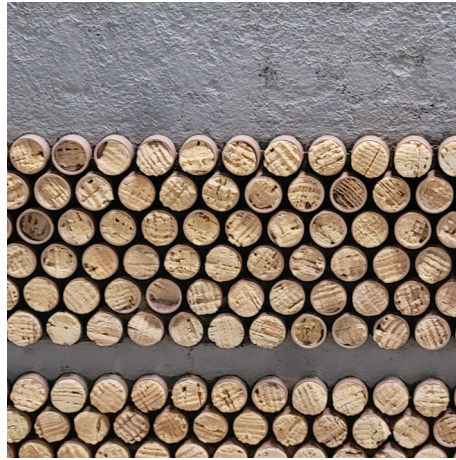
Corrosion and scale are removed and metal is blasted to prep for coating application.

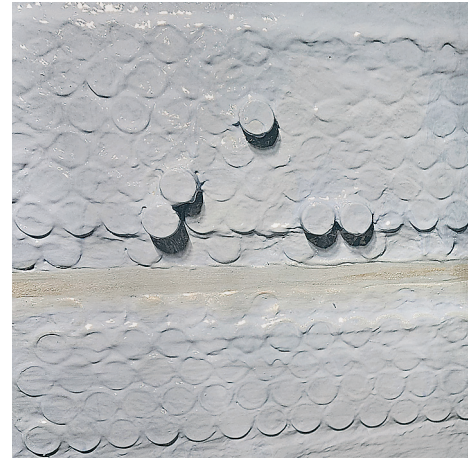
Metal loss is rebuilt, then first step of Belzona 1341 gray coating is applied.

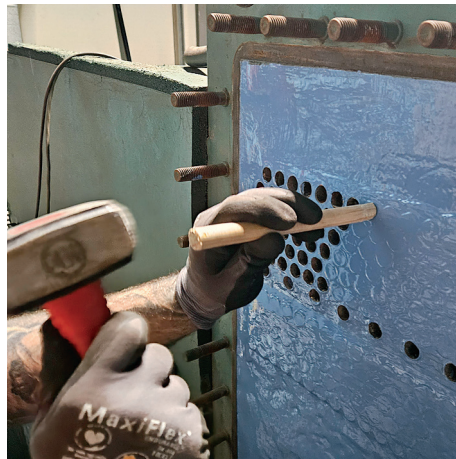
Corks are tapped into exchanger tubes after coating has cured.

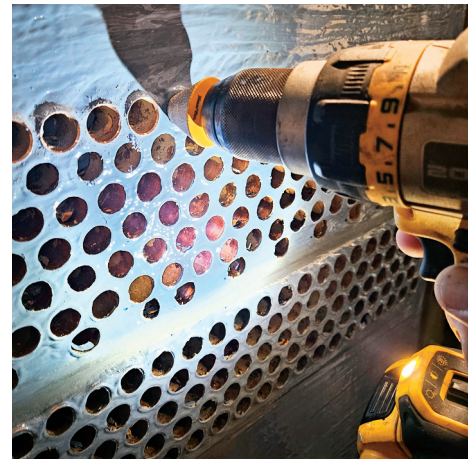
Tube ends are chamfered to remove residual coating overlap.

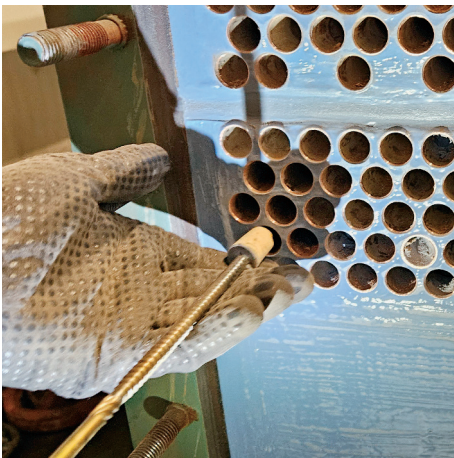
All sunken corks are removed from within the heat exchanger tubes.

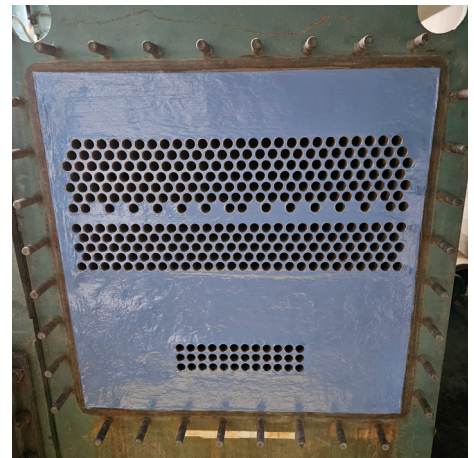
Completed tube sheet restoration ready for service after final inspection.
