# EMERGENCY FIBERGLASS PIPE REPAIR

## Rapid Pipe Repair Saves New Jersey Power Station from Costly Outage

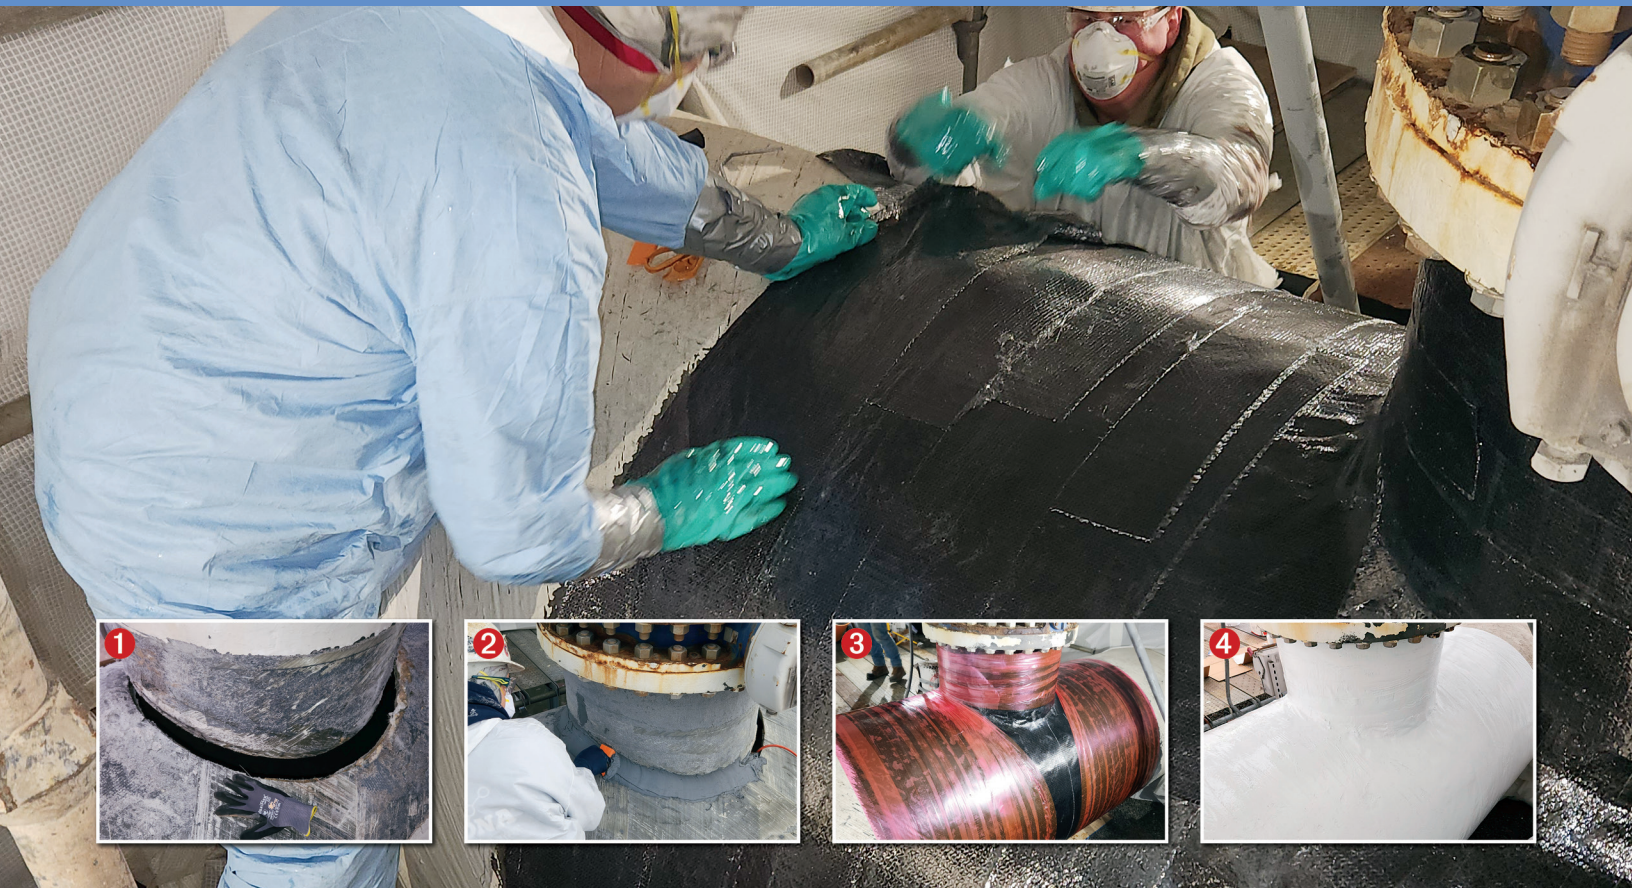
A natural gas power station in Northern New Jersey faced a critical emergency when a vital cooling water pipe ruptured due to extreme cold and aging. With power generation at risk, our team mobilized within hours. By 2 pm, skilled crews were on-site, assessing damage and executing a complex repair. A large pipe gap posed a challenge, but using advanced materials like Belzona epoxy resin and Superwrap repair systems, we sealed and reinforced the structure. Working tirelessly, we restored operations within 36 hours, preventing costly downtime. This success highlights our commitment to safety, teamwork, and innovative infrastructure solutions.

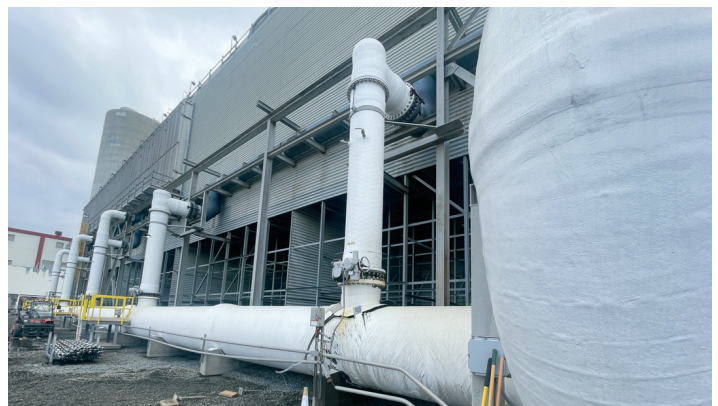
Cooling tower with ruptured beetle pipe.

- 1 Pipe break prepped and cleaned for refit
- 2 Belzona paste seals gap and bonds pipe sections
- 3 Belzona Superwrap restores pipe wall strength
- 4 Final Belzona protective coating applied
