NON-SLIP COATING FOR DOCK LEVELERS

Slip Reduction Coating Solves Problem of Slick Diamond Plate Dock Levelers

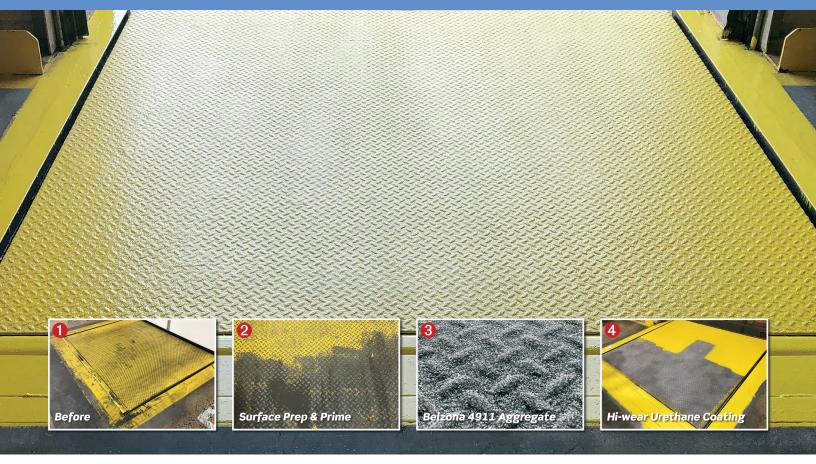
Slippery diamond plate dock levelers made a Philadelphia distribution center unsafe, especially during rainy days. Banks Industrial Group mitigated this hazard through the rapid application of a non-slip, high-adhesion Belzona coating resistant to impact and abrasion. Unlike adhesive strips, this coating will not peel away and will provide a long service life, applied and cured quickly. This loading dock was repaired and returned to service within 48 hours.

Same dock shown after 18 months service.
